Manhole Inspection Summary

Manhole # S11KK1043MH

Insp Date: **1/20/09 4:27 PM**

Location Address: **3300 VIRGNIA AVE**

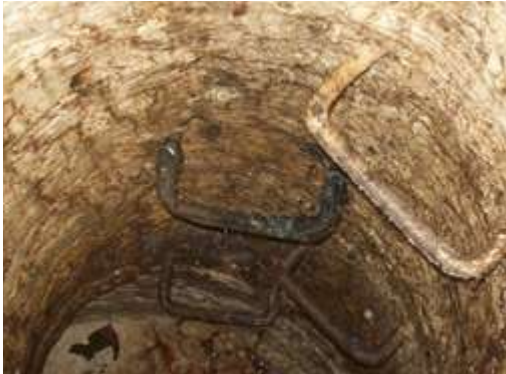
Defect 2

Count: **6** Missing: **0** ☒ Corroded

☒ Evidence Of Surcharge

Depth: **8.5** (ft.) ☐ Active Surcharge Present

SURCHARGE EVIDENCE AND
CORRODED STEPS

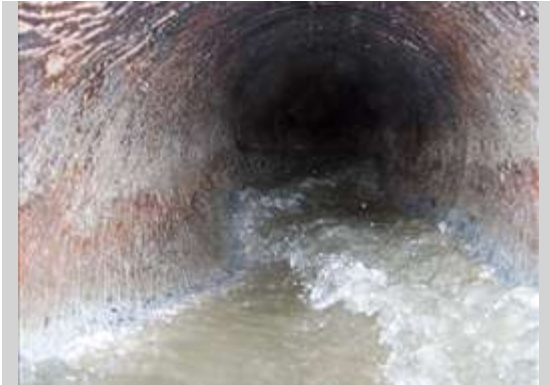
12 O'Clock Outflow

18 in. Circular Gravity Sewer
Pipe Out @ 12 O'Clock

Pipe Material: **PVC** ☐ Pipe Lined

Invert Depth: **12.48** (ft.) Flow Characteristics: **Turbulent**

Deposits: ☒ None ☐ Mud ☐ Sludge ☐ Debris ☐ Grease

Infiltration: **None** Pipe Seal Cond: **Sound**

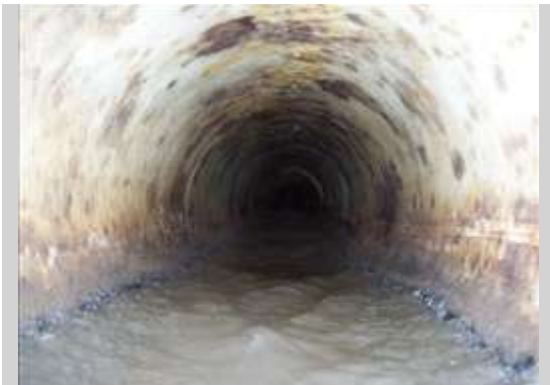
5 O'Clock Inflow

18 in. Circular Gravity Sewer
Pipe In @ 5 O'Clock

Pipe Material: **PVC** ☐ Pipe Lined

Invert Depth: **12.18** (ft.) Flow Characteristics: **Fast**

Deposits: ☒ None ☐ Mud ☐ Sludge ☐ Debris ☐ Grease

Infiltration: **None** Pipe Seal Cond: **Sound**

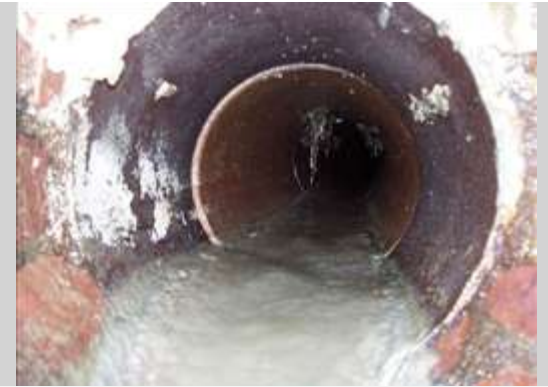
6 O'Clock Inflow

10 in. Circular Gravity Sewer
Pipe In @ 6 O'Clock

Pipe Material: **Clay** ☐ Pipe Lined

Invert Depth: **11.92** (ft.) Flow Characteristics: **Slow**

Deposits: ☒ None ☐ Mud ☐ Sludge ☐ Debris ☐ Grease

Infiltration: **None** Pipe Seal Cond: **Sound**
